FW: San Miguel B-North Haul Road

Subject: FW: BN-2 Drop Structure Meeting

# **BN-2 Drop Structure Sedimentation Structure Inspection List**

# BN-2 Drop Structure Action Plan

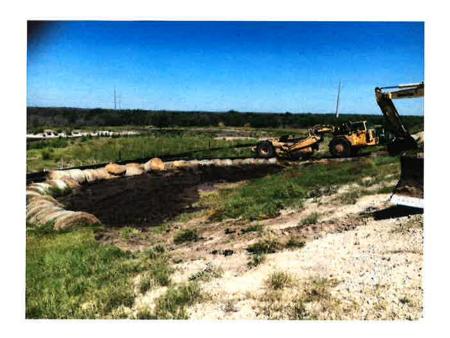
10/10/16

One item that was noted in the meeting was SMEC did not notify Inspection Staff when repairs were made in response to inspection reports. In the future, SMEC will make it a practice to inform Staff what has been done to respond to items noted in inspections. Our records show work was done on the BN-2 drop sedimentation structure by Kiewit and other contractors on July 27, 2015; January 29, 2016; March 10, 2016; July 21, 2016; August 3, 2016; September 27, 2016; October 11, 12 and 13, 2016. Photographs of the October 11, 12 and 13 repairs are attached, as mentioned above.
